Property Inspection Report

4673 Sugar Drive
Pembroke Pines Fl, 33333

Prepared for: Buyer Name

Prepared by: KRC Home Inspection Company
8589 SW 22 Ct
Miramar, Fl 33025

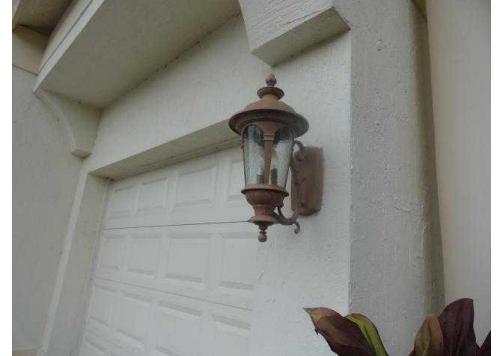
Repair: **Lighting:** Wall mount: One light did not operate ,
replace bulbs to verify function of lights /
Recommend further evaluation by a qualified
electrician

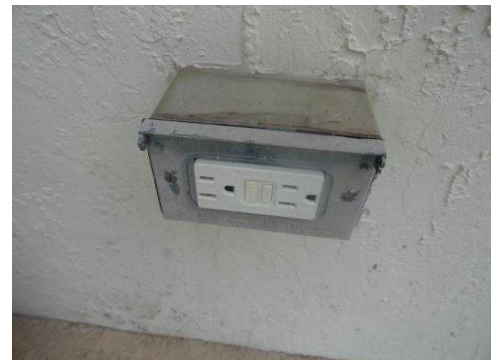
Functional: **Electric Outlets:** 110 VAC GFCI: No weatherproof cover on
outside outlet(s)

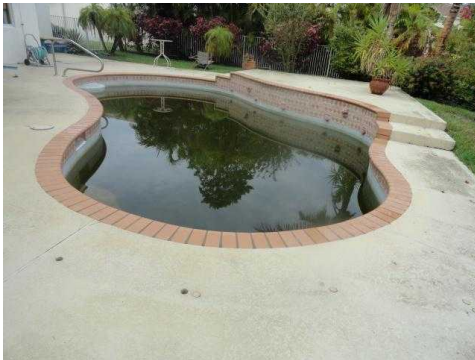
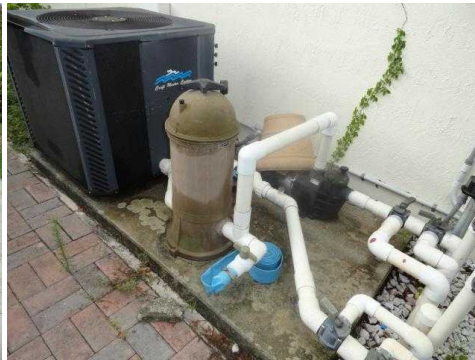
Repair: **Type:** In ground: Low water level at the time of inspection, Have pool check for possible leaks, Pump did not operate, A qualified pool company is recommended to evaluate and estimate repairs prior to closing

Repair: **Water Level:** Low: Low water level at the time of inspection, cloudy

Repair: **Pump Motor:** Pool pump did not operate at the time of inspection

Swimming Pool Type: Low water level at the time of inspection, Have pool check for possible leaks, Pump did not operate, A qualified pool company is recommended to evaluate and estimate repairs prior to closing

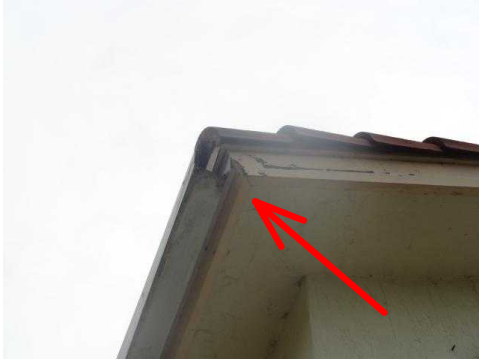
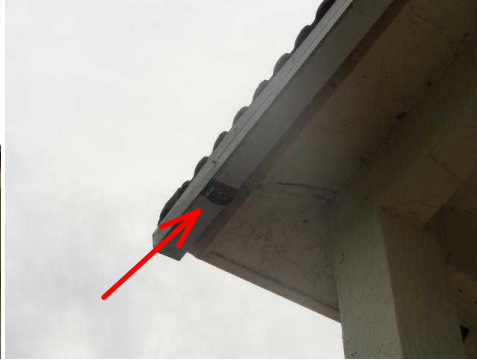
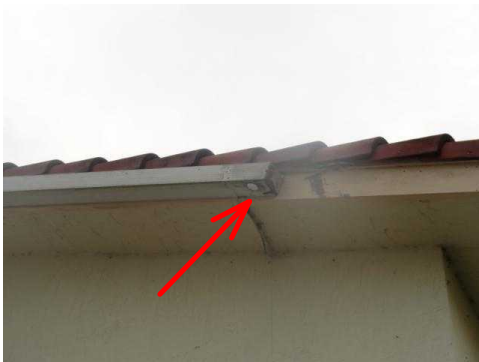
Repair: Downspouts: Missing at rear, no report cost reported

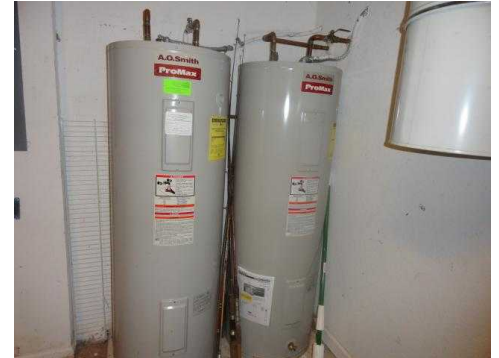
Remarks: 2 water heater present

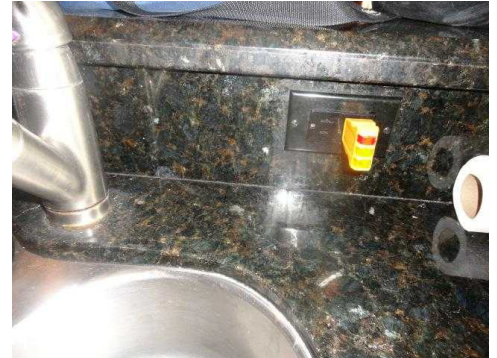
Repair: **Accessible Outlets:** 110 VAC GFCI: Hot and ground reversed at back splash right of sink
Cost to Repair Low: \$ 75 - High: \$ 100

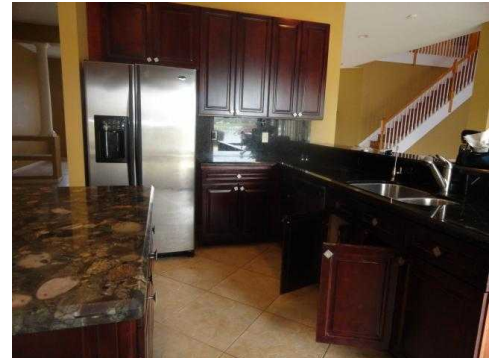
Repair: **Cabinets:** Wood: Cabinet overall is showing spots of damage, Damage flooring underneath the sink, no repair cost reported, obtain cost from a qualified contractor if necessary

Kitchen Cabinets: Cabinet overall is showing spots of damage, Damage flooring underneath the sink, no repair cost reported, obtain cost from a qualified contractor if necessary

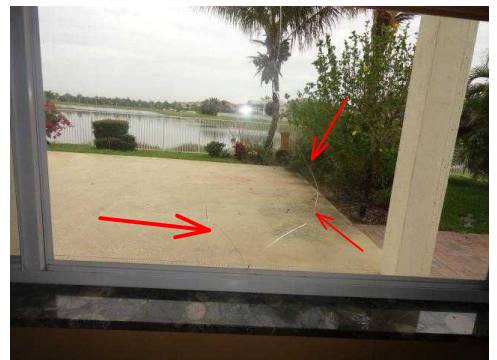
Repair: **Window Type:** Horizontal Slide: Broken window glass - replace

Cost to Replace Low: \$ 300 - High: \$ 500

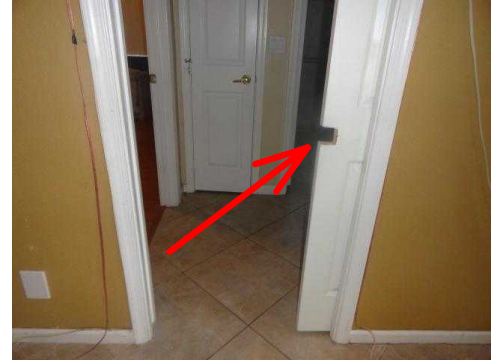
1st Floor Hall Room/Living Space

Functional: **Closet:** Linnen closet:
Functional: **Ceiling Type:** Drywall:
Functional: **Wall Type:** Drywall:
Functional: **Floor Covering:** Ceramic tile:
Functional: **Lighting:** Recess light:
Repair: **Doors:** Pocket door: **Missing hardware**
Cost to Repair Low: \$ 75 - High: \$ 150

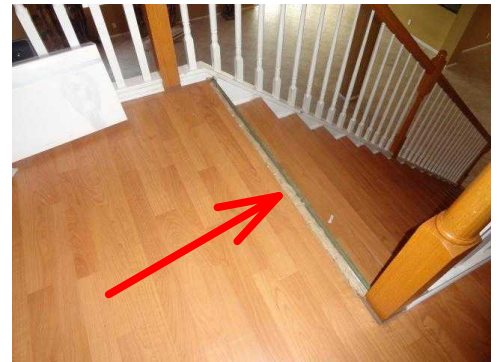
Loft Room/Living Space

Functional: **Ceiling Type:** Drywall:
Cosmetic Flaws: **Wall Type:** Drywall: Nails / screw holes in wall
Cosmetic Flaws: **Floor Covering:** Wood: Missing piece at step, no
repair cost reported

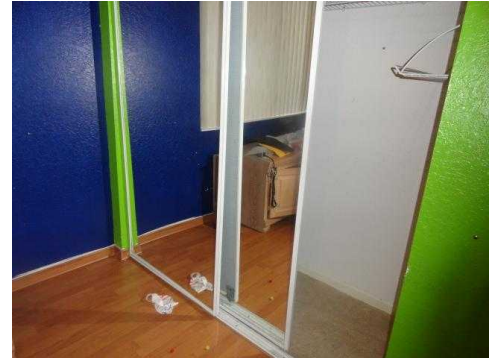
Repair: **Closet:** Single closet: Align / adjust closet doors

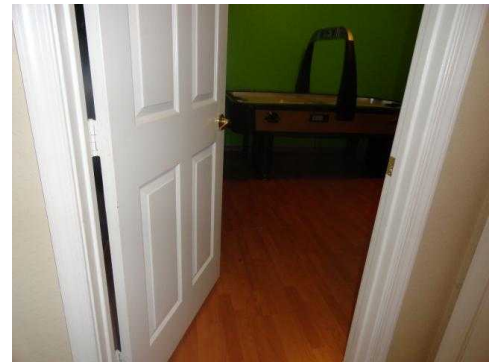
Repair: **Entry Doors:** Hollow wood: Lockset(s) not latching-requires adjustment

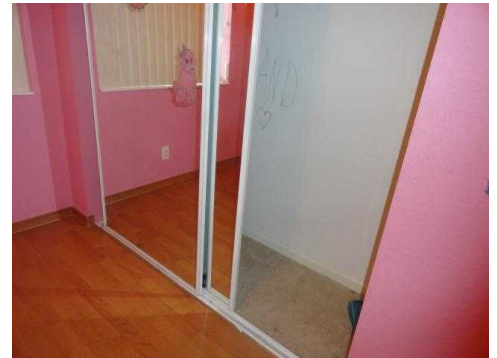
Master Bedroom

Repair: **Closet:** Walk-in closet: Align / adjust mirror closet doors

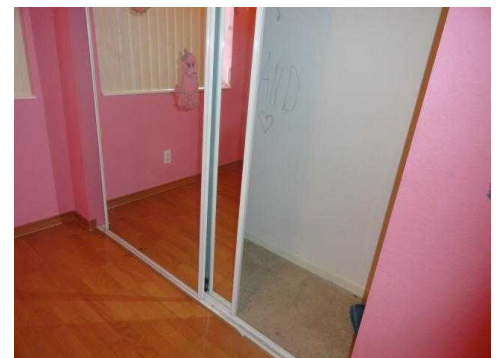
Third Bedroom

Repair: **Closet:** Single closet: Align / adjust mirror closet doors

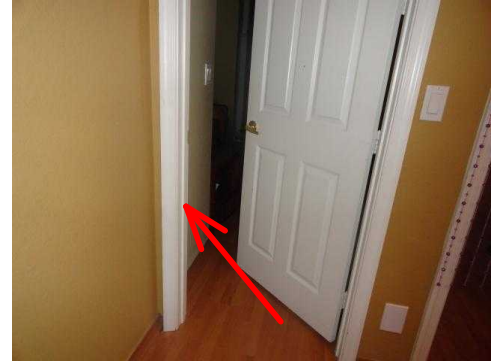
Functional: **Ceiling Type:** Drywall:
Cosmetic Flaws: **Wall Type:** Drywall: Nails / screw holes in wall, paint needed overall
Functional: **Floor Covering:** Wood:
Repair: **Entry Doors:** Hollow wood: Loose / unsecured door jamb
Cost to Repair Low: \$ 100 - High: \$ 150

Third Bedroom Entry Doors: Loose / unsecured door jamb

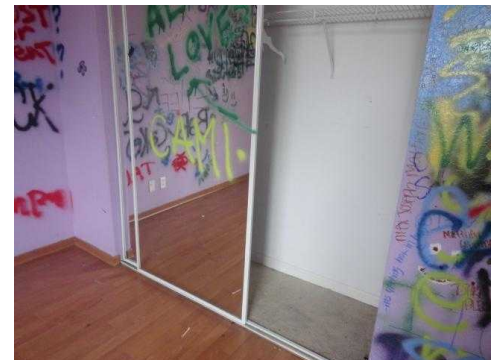
Fouth Bedroom

Repair: **Closet:** Single closet: Align / adjust mirror closet doors

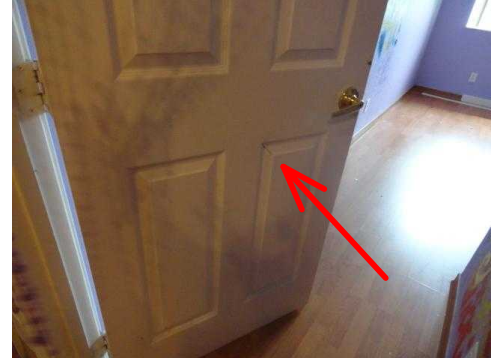
Repair: **Entry Doors:** Hollow wood: **Damage entry door**
Cost to Replace Low: \$ 300 - High: \$ 500

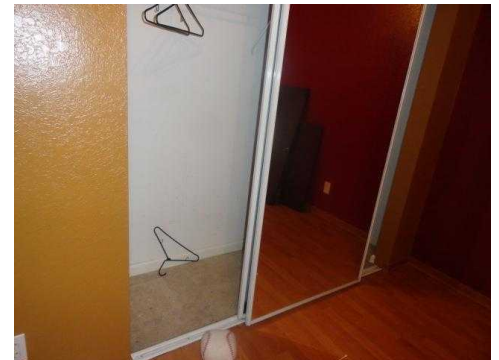
Fifth Bedroom

Repair: **Closet:** Single closet: **Align / adjust mirror closet doors**

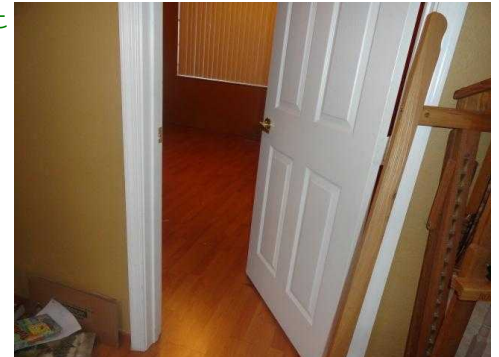
Repair: **Entry Doors:** Hollow wood: **Entry door rubbing against the jamb**

Cost to Repair Low: \$ 50 - High: \$ 75

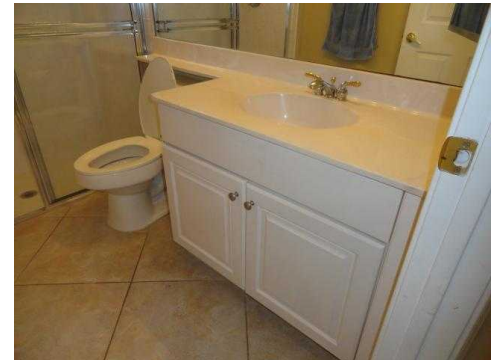
1st floor Bathroom

Functional: **Ceiling Type:** Drywall:
Functional: **Wall Type:** Drywall:
Functional: **Floor Covering:** Ceramic tile:
Functional: **Entry Doors:** Hollow wood:
Functional: **Window Type:** Horizontal Slide:
Functional: **Lighting:**
Functional: **Accessible Outlets:** 110 VAC GFCI:
Repair: **Counter/Cabinet:** Marble, Laminated and composite material:
Align / adjust cabinet doors

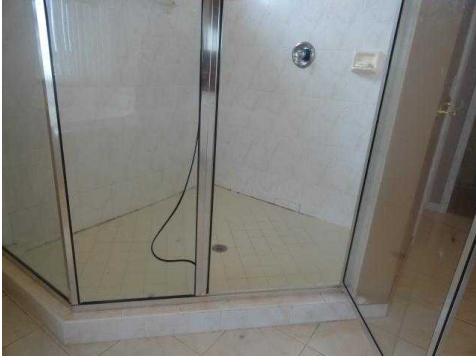
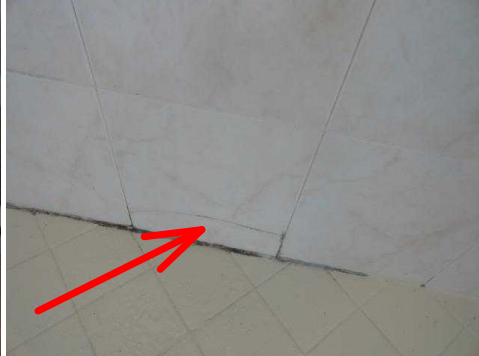
Functional: **Sink/Basin:** Two single sink:
Functional: **Faucets/Traps:** Faucet with a PVC trap:
Repair: **Shower/Surround:** Ceramic tile pan with ceramic tiles surround: Adjust / repair shower door, damage glass seal, crack wall tile
Cost to Repair Low: \$ 400 - High: \$ 600

Master Bathroom Shower/Surround: Adjust / repair shower door, damage glass seal, crack wall tile

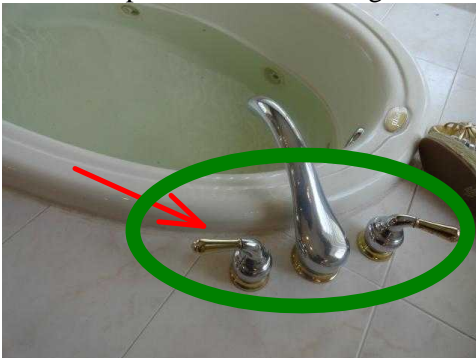
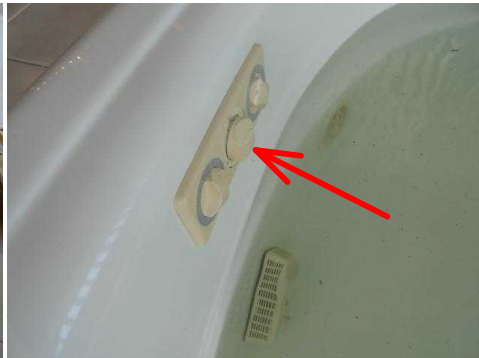
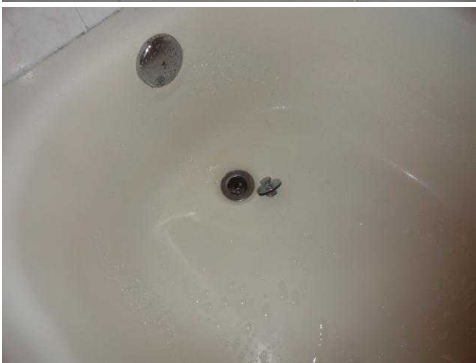
Repair: **Spa Tub/Surround:** Fiberglass tub: Jacuzzi pump appears functional, defective tub faucet, missing drain stopper, broken knob
Cost to Repair Low: \$ 300 - High: \$ 500

Master Bathroom Spa Tub/Surround: Jacuzzi pump appears functional, defective tub faucet, missing drain stopper, broken knob

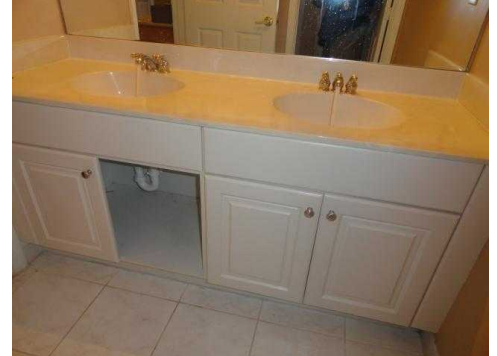
Repair: **Counter/Cabinet:** Marble, Laminated and composite material:
One door off the hinge, door located in the bathroom
Cost to Repair Low: \$ 50 - High: \$ 100

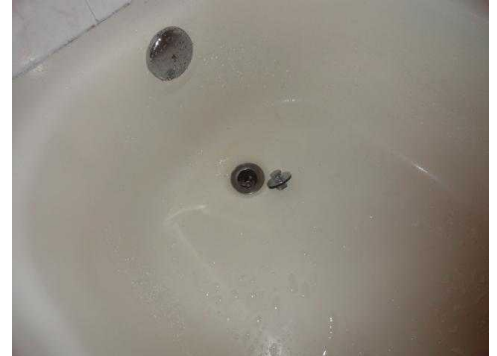
Functional: **Sink/Basin:** Two single sink:
Functional: **Faucets/Traps:** Faucet with a PVC trap:
Repair: **Tub/Surround:** Steel tub with ceramic tiles surround: Adjust / repair drain stopper

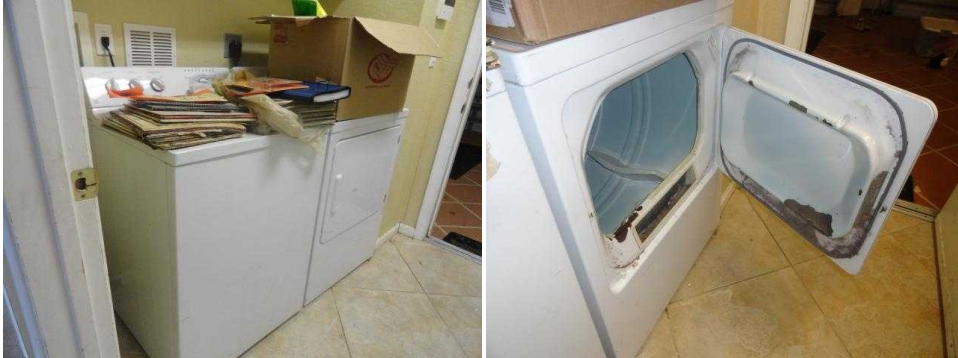
Functional: **Washer:** General Electric
Repair: **Dryer:** General Electric **Faulty start switch, chip noted on unit**
Cost to Replace Low: \$ \$400 - High: \$ 600

Laundry Room/Area Dryer: Faulty start switch, chip noted on unit
